Changing Humber Valley's bridge timber decking to steel without a complete closure

Project Name: Humber Village Bridge - Deck Replacement

Application: Bridge Rehabilitation

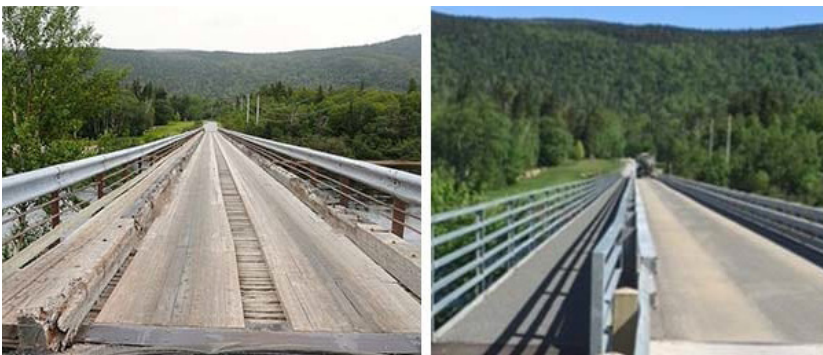
Our Algonquin Modular Panel Bridge components and steel decking were used to create a new top on the existing steel beam super structure. This replacement system allowed traffic to still use the bridge at scheduled peak times and evenings during construction.

The old bridge had a 3 m roadway and only a .7 m footway, with no adequate protection between pedestrians and vehicles. The components generated a 3.35 m roadway with a cantilevered and protected footway that is 1.5 m wide, thanks to the extended transoms.

The contractor's crew gradually worked their way across the bridge, section by section, removing the old timber decking and installing the new galvanized epoxy-aggregate, anti-skid decking. Scheduled temporary re-openings occurred for peak travel times, evenings and weekends with vehicles crossing partly on the old deck and partly on the new deck.

Since the ends of the original steel girder bridge were earlier extended by 3 m "Bailey" approach panels, the contractor had to place the first new transom at a precise location in order for the steel decking sections to work out properly at the other end. They also had to deal with the old bridge's hand-drawn plans that were not always accurate. Plus, the old girders had variable flange thicknesses and gusset plate locations that needed to be made to fit with the new components.
