## Algonquin's R800 Modular Panel Bridge provides a cost-efficient bridge solution for Ginoogaming First Nation

A 27.4 m Algonquin R800 Modular Panel Bridge provided a cost-effective replacement for the Ginoogaming First Nation KM 132 Bridge.

**Project Name:** Ginoogaming KM 132 Bridge Replacement

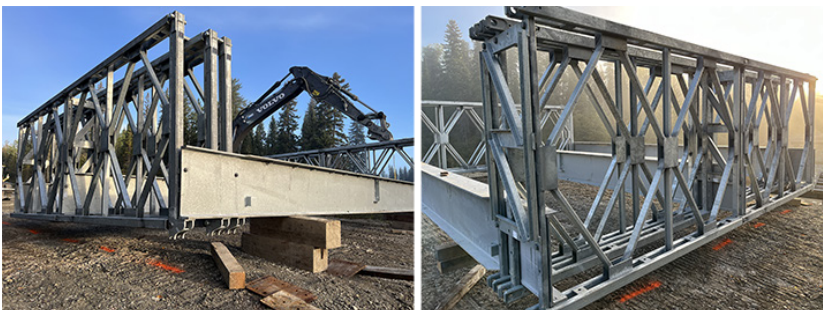
Before installation could begin, the existing bridge and 18 old wooden vertical piles had to be removed. This was the only work completed in-water. Once assembled, the Algonquin R800 Modular Panel Bridge is able to be cantilever launched from one side or crane-lifted into place, eliminating the need to disturb the natural stream channel during installation.

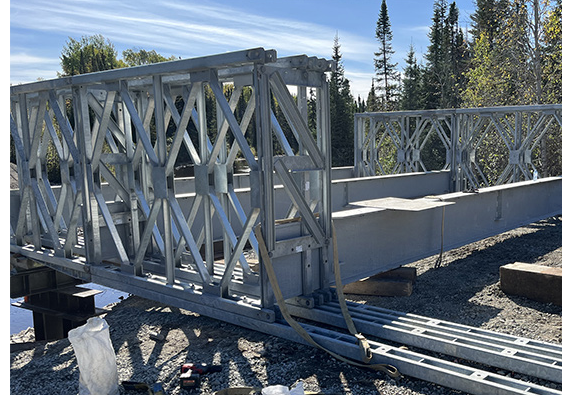
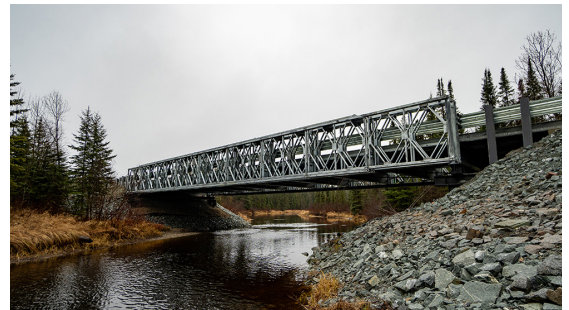
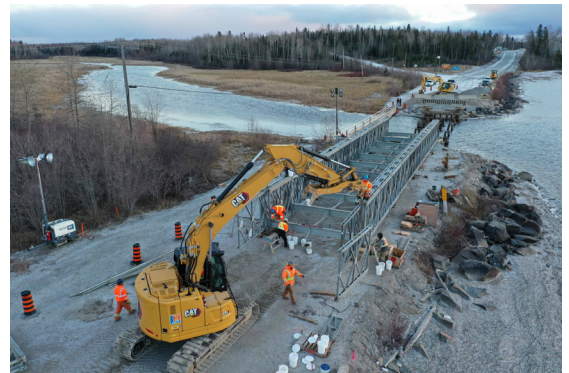
Photo of second bridge courtesy of LHNorth

After the installation of this structure, another was bridge was condemned on the same road (the Making Grounds Bridge). This led to an unplanned closure that cut the local First Nations community off from a nearby town. A state of emergency was issued and Algonquin Bridge, along with LH North Construction, delivered a bridge to the site in less than a week after receipt of purchase order. This bridge was installed quickly by the LH North team and community access was restored.
